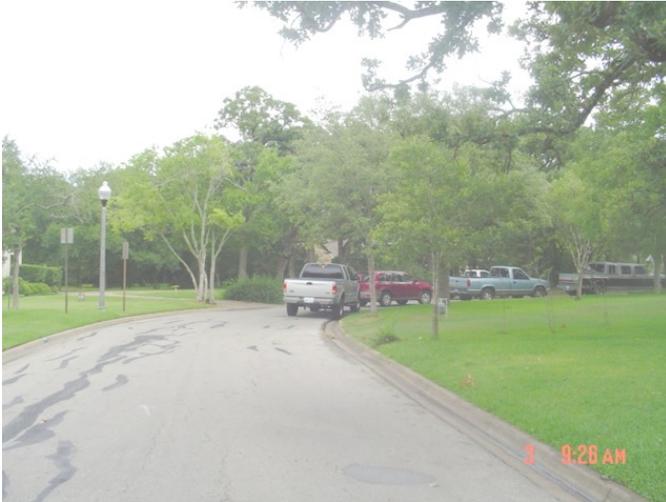
This picture was taken near the intersection of Suffolk Avenue and Burt Street looking northbound. It presents the limited view that northbound vehicles have of opposing traffic coming around the corner. For example, the second truck from the right is limiting the ability of a northbound vehicle from seeing the white truck traveling southbound around the corner.

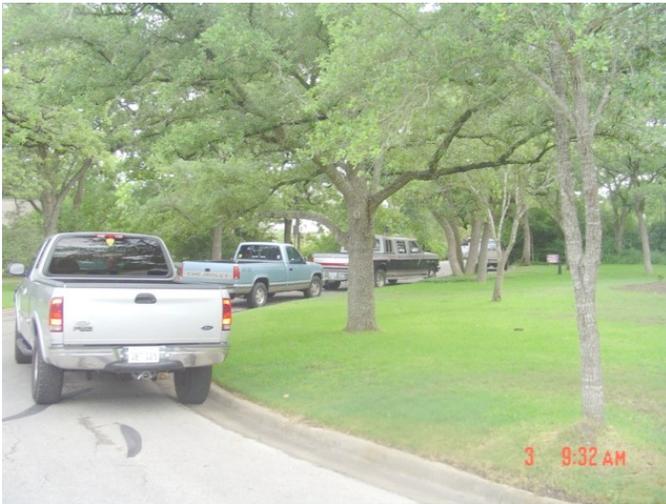
In the previous picture, it can be seen that the road curves to the right. However, due to the vehicles parked along the south side of Suffolk Avenue, it is difficult to see that after the road curves to the right, the road has two more curves.

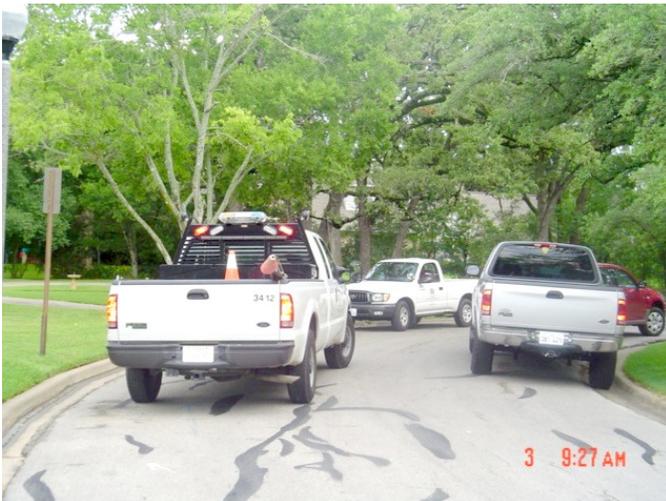
This picture shows that with the parking allowed on the south side of the street, opposing traffic cannot easily pass.
